PROJECT PROFILE

Project: Rehabilitation of Gravity Thickener Tank #1

Location: Sand Island WWTP – Honolulu, Hawaii

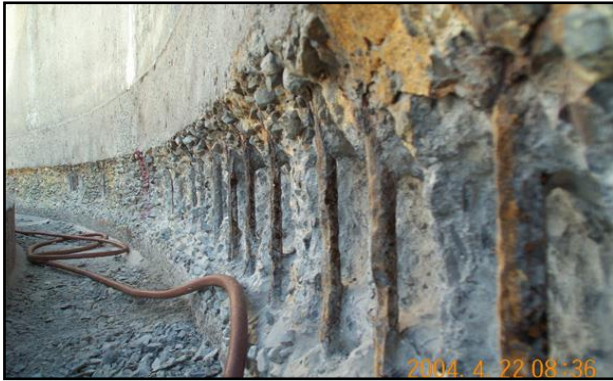
Eroded and corroded trough wall following hydro-blast prior to rehabilitation.

- All concrete surfaces were blasted and resurfaced using SubstrateResurfacer F-121 to restore original grade and provide a uniform surface for the application SewerGard epoxy linings.
- In areas of severe corrosion and erosion, namely in the trough areas, F-121 was installed at up to 4” in thickness to restore grade.
- Following restoration and resurfacing, SewerGard No. 210T was installed in trough areas at a minimum 125-mil thickness and then top coated with 210G. The smooth 210G surface reduces debris and algae build-up and aides in cleaning efforts while providing superior abrasion resistance.
- Wall areas were protected with a 20-mil lining of 210G providing excellent corrosion protection.

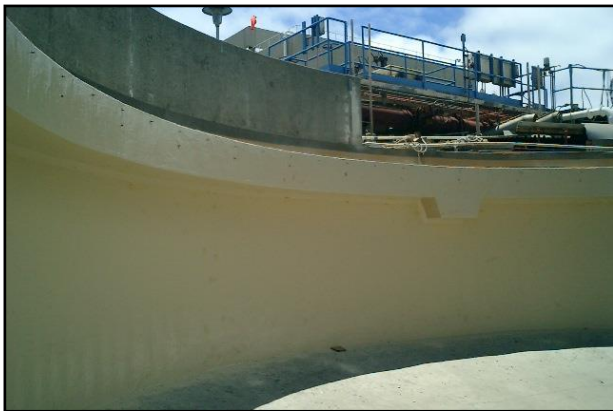
View of completed walls protected with SewerGard 210G

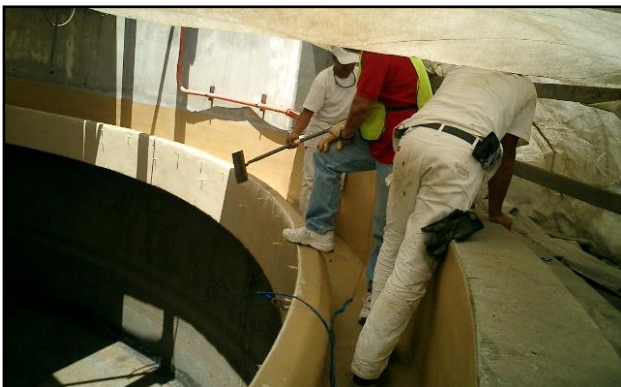
Rehabilitated trough protected with SewerGard 210T and 210G top coat to ease cleaning and maintenance.
